Bats in Churches

Guidelines for the identification, assessment, and management of bat-related damage to church contents (furnishings, fittings, and works of art)

ENGLISH HERITAGE

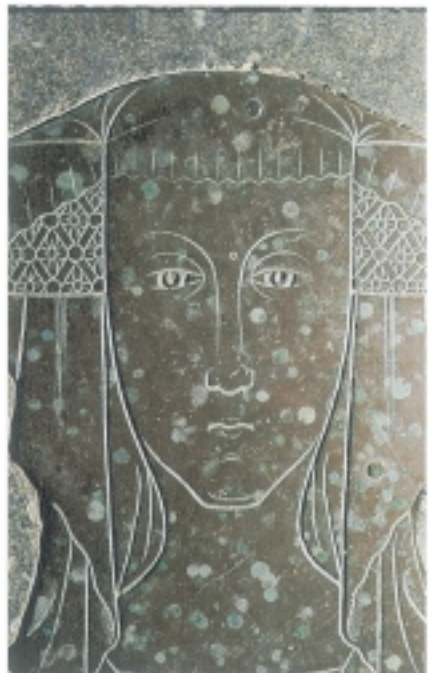
A brass at Broughton Church, Oxfordshire, of Philippa Byschoppesdon, dated 1414, which has suffered disfiguring surface erosion from droplets of bat urine

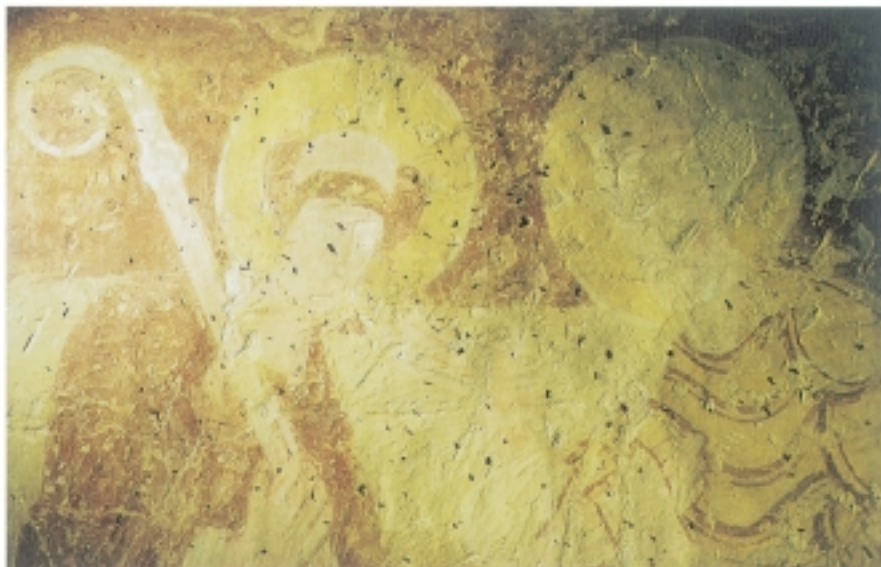
The internationally renowned scheme of wall paintings (dated c 1100) at Clayton Church, East Sussex, has been exposed to bat excreta as the result of this church being used as a roosting site. While the presence of urine can often be difficult to see because of the porous nature of a wall surface, droppings are more easily identifiable, as seen here

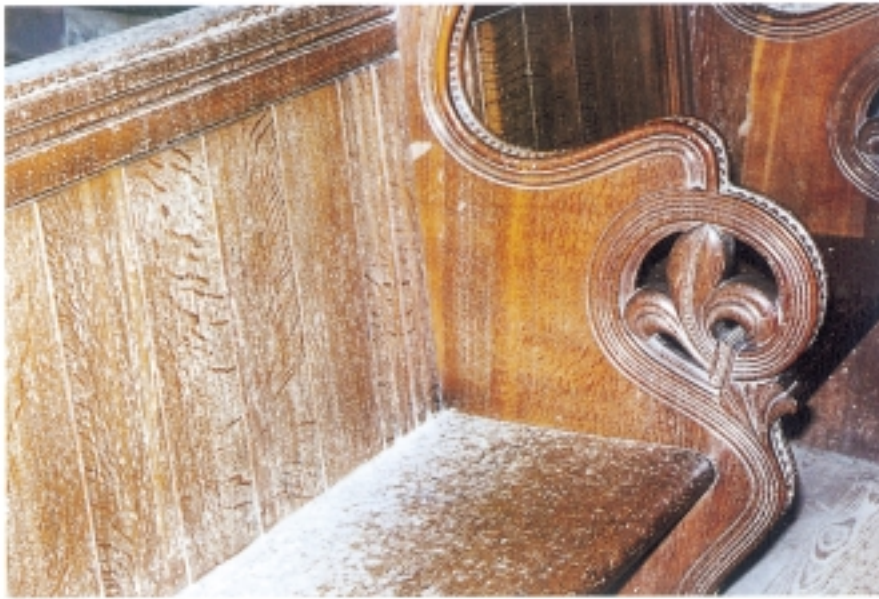
At Brinkburn Priory, Northumberland, a nineteenth-century pew displays evidence of both visual and surface damage to the wooden surface from the development of microbiological organisms forming on an area of extensive urine deposition

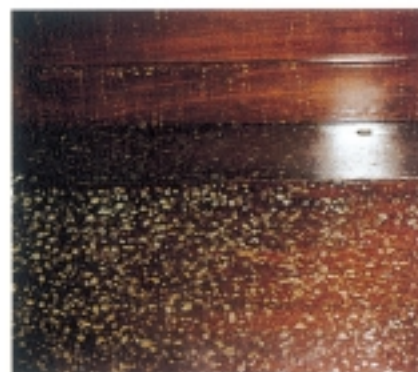
Any wooden surface previously treated with an organic varnish layer or wax coating is particularly vulnerable to the effects of bat urine. Here the polished top to an organ at Clayton Church, East Sussex, displays the typical effects of surface etching resulting from the strong alkalinity of bat urine when in contact with such coatings

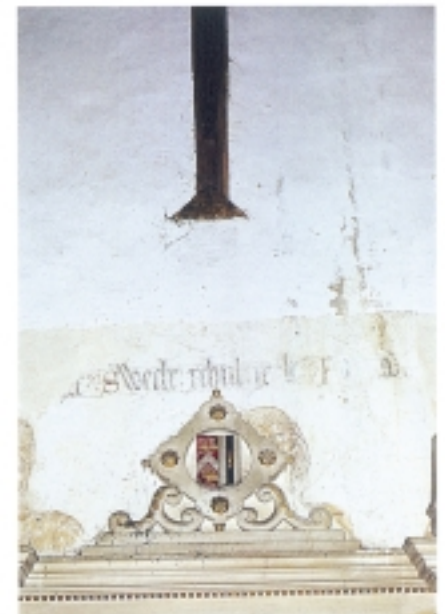
A roost site at Heydon Church, Norfolk, has been positioned above a sixteenth-century monument, which also covers part of an earlier fourteenth-century wall painting. The accumulation of bat droppings is not only visually impairing, but will also be responsible for a variety of other deterioration phenomena, both to the stonework and to the pigments of the wall painting

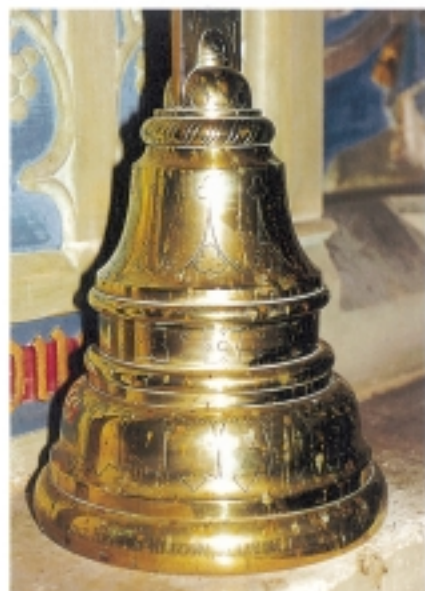
A brass candlestick displays the typical effects of surface erosion and staining that can result from bat urine

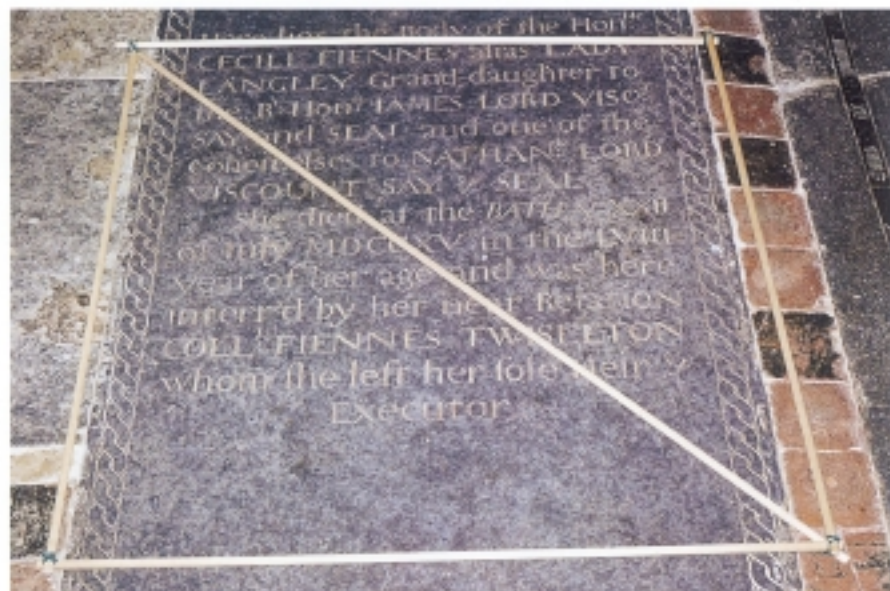
Since evidence for the presence of bats can be detected through damage to woodwork, stone, metals, and other vulnerable surfaces, it is useful to chart these effects by counting the visible damage marks on surfaces and plotting these on a plan of the church. A measuring frame, as shown here, assists in developing a systematic approach to this exercise. Such information will give a useful indication of both the rate and distribution pattern of bat excreta throughout the building

assessment of both the amount and distribution of bat excreta, however, recording onto a scale plan of the church is very useful. Divide the plan up into one-metre square sections, count the number of spots of urine or droppings in each square, and record on the plan. A hand-held one-metre square frame or quadrant may help.

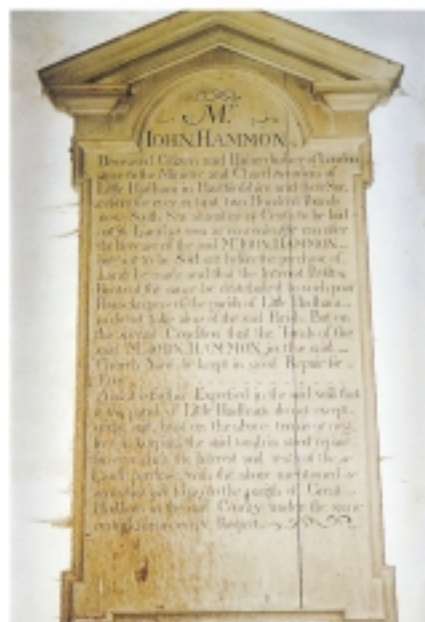
A nineteenth-century memorial board at Little Hadham Church, Hertfordshire, shows the dramatic consequences of a bat roost positioned immediately above. This concentration of excreta around the roost is typical, causing great risk to any exposed object below

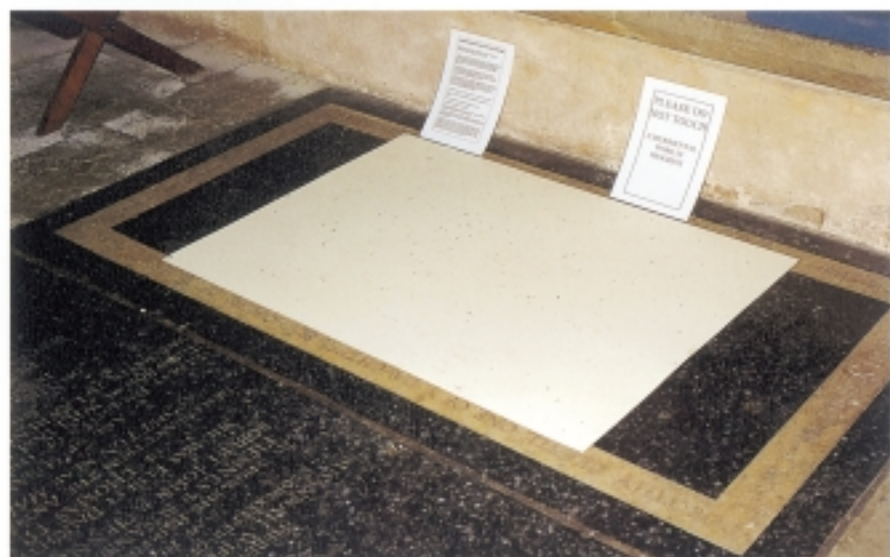
The church at Broughton, Oxfordshire, was used as part of the experimental work in developing a number of ways that parishes could begin to monitor and ameliorate a bat problem. Here one metre square cards were positioned over an area of the chancel floor. These were left in place for a number of months during which time individual droppings and urine droplets were systematically counted. This yielded useful baseline data on the active rate over time of the deposition of bat excreta occurring in this part of the church

- more accurate, further assessment of the rates of deposition in those more specific areas. This can be achieved using light-coloured one-metre square sample cards located beneath known roosts, access points, other areas with a concentration of urine spotting, or near objects of particular historic or artistic concern (eg tomb top or floor-

mounted brass). The cards should be in place between May and at least October or November. Count the number of urine spots and faeces which fall during two- or four-weekly periods over the season (see Table 2). A hand-held UV lamp available from conservation supply specialists (see below for stockists) will help illuminate

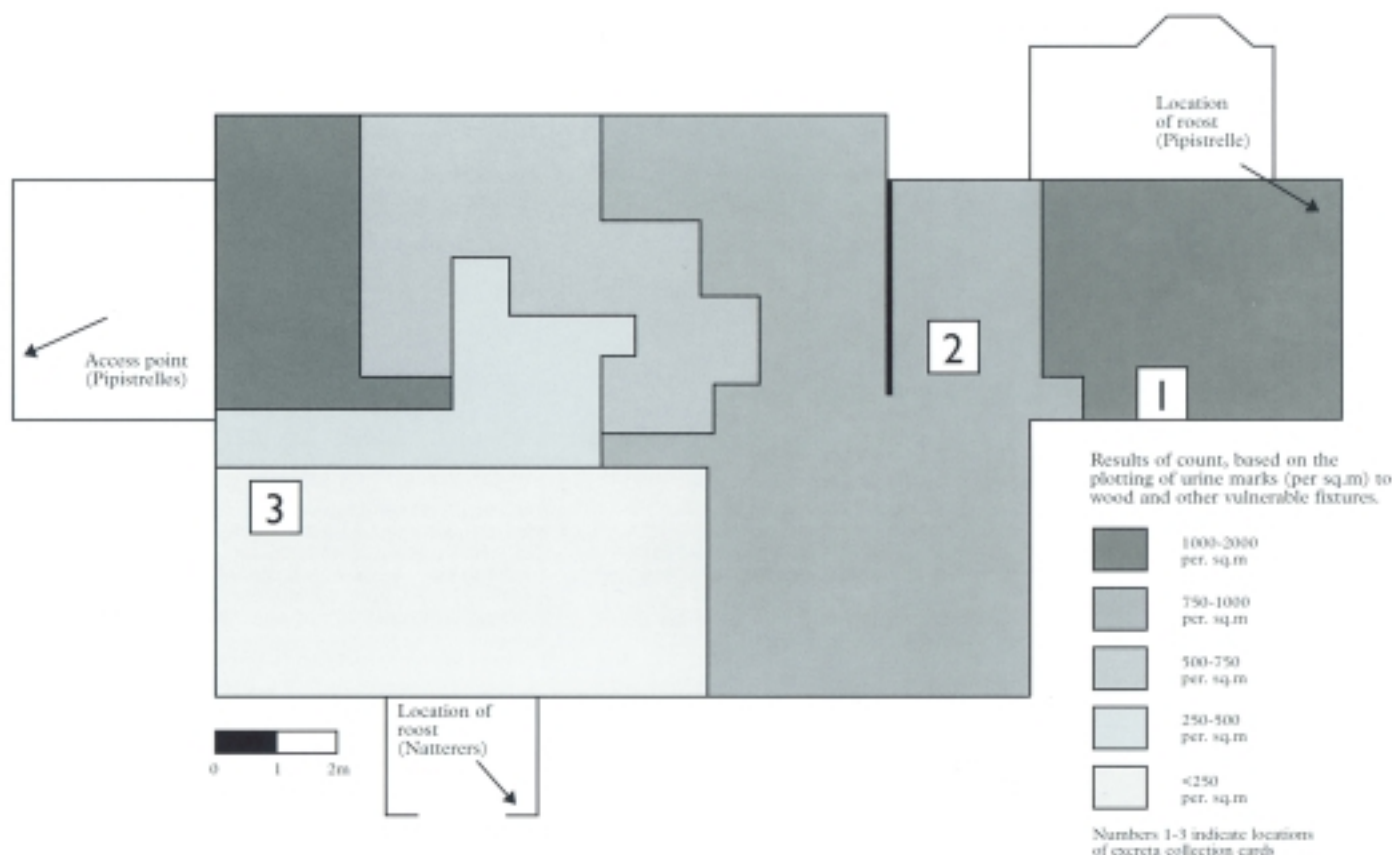
The example of Broughton Church, Oxfordshire, shown in the plan below and Table 2 indicates that the area of highest deposition is in the chancel (1) and lowest deposition in the south aisle, west end (3). In this

case the pattern of deposition is mirrored by both assessment methods (accumulative and current). Pipistrelle bats enter the church near the West Door but the roost is at the extreme east end, in the chancel. Deposition is highest in these areas. Bats fly the length of the church from their access point to their roost. There is less bat activity in the south aisle. Although there is a Natterer's bat roost in the south porch, these bats do not enter the church.

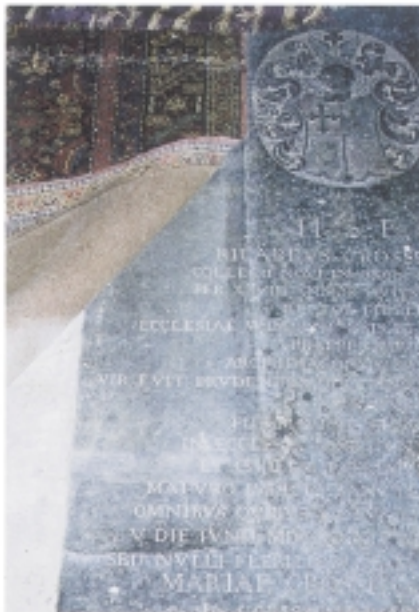
This carpet at Broughton Church, Oxfordshire, offers some protection to an exposed stone floor slab. This example amply demonstrates not only how harmful bat excreta can be, but also emphasises how important is the need to instigate appropriate measures to safeguard historic and artistic objects in churches where bats are present

- **Covers** Covers may be appropriate when deposition is localised or when there are only a few vulnerable objects. Covers are less suitable when deposition occurs throughout the church, as the aesthetic impact would be significant. Porous materials such as linen or natural carpet are suitable, but polythene, which may create a moist microclimate around the object, should not be used. All covers should be placed and removed with care to avoid any mechanical damage. A layer of carpet or underfelt would be suitable for a floor-mounted brass but any grit should be removed regularly to avoid damaging the brass surface. Underfelt can be sewn onto a layer of natural fibre carpet for added protection but foam backed carpet or plastic sheeting should not be used.
